**Flood Control Project Maintenance
Levee Inspections**
LMA District Cover Sheet
Spring 2018 Levee Inspection Results

Reclamation District No. 0544 Upper Roberts Island

Spring 2018 Levee Inspection Results

Waterway			Bank	Unit Miles
Unit No. 01 San Joaquin River			Left	6.05
	Spring (March - May)	Summer (June - August)	(September - November) Fall	Winter (December - February)
Unit Maintenance Rating (Fall Only)				
Date of Inspection	4/26/2018 - 4/26/2018			
DWR Inspector	Richard Willoughby			
Accompanied By	Richard Toy KSN

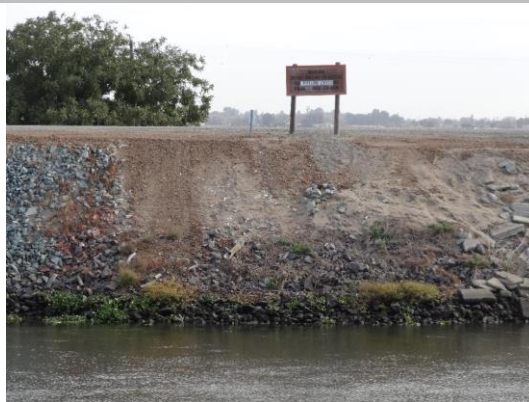
Photo 2 of 3 : UCIP_SP_2018_41906_41712.jpg

WS view: a signboard indicating a gasoline across the river channel.

Comment Code						
Inspector Comment						
FS_ID:41906 DS_ID:22640 EP_NO: 4116 Repair Type: Non-Urgent Crossing Status: Found UCIP Comments: Need to contact owner to determine status.- a signboard on waterside shoulder and across the river.- no indicators on landside. FIELD_STRUCT_DESC: 8.625-inch steel natural gas pipeline through the levees and under the river, 3.9 feet below the crown. Waterside (WS) slope rock revetted. (Plans for installation of an 8.625-inch gas line under the San Joaquin River and through the levees authorized under Permit No. 4116, 1962 - Pacific Gas and Electric Company [PG&E]). [Additional Reference(s): DWR Levee Log, 2005. USACE San Joaquin O&M Manual 7, April 1964, (HLM 0.01)]. FS Date: 10/29/2013

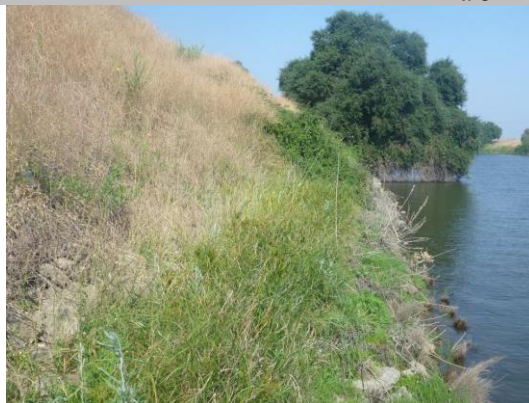
Photo 1 of 3 : LEVAL_SP_2018_571_4478.jpg

LM Start	0.64	Rating **	A/W	Issue No.	75
LM End	0.64	Issue Type +	Ma	Location *	
Category	Supplemental			GPS Latitude/Longitude	
				Start	End
Item	2017 Storm Damage			37.863900 °	37.863900 °
				-121.323500 °	-121.323400 °
DWR ID	DWR_RD0544_01_f _ 2017_75				
Comment Code					
Inspector Comment					
Levee Evaluation Comments					
Description:Slope protection repairs are needed along the waterside slope due to erosion and riprap displacement from high water. Based upon levee inspections, it was determined the waterside levee slope is eroding, deteriorating, and degrading. The eroded levee sections need to be restored back to design standards to prevent further deterioration and damage.					
Site ID No:571					
Site Designation:LMA-477					
Repair Type: Erosion					
Rating:Area of Concern					
Field Date:8/10/2017					
Notes:

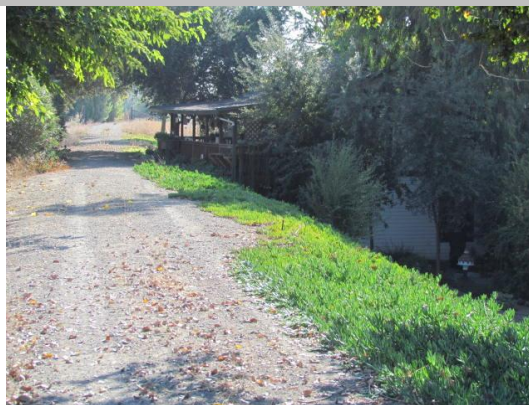
Photo 2 of 2 : SP_2018_RD0544_108_9_20180323_00016.jpg

Looking south at landscaping on landward slope.

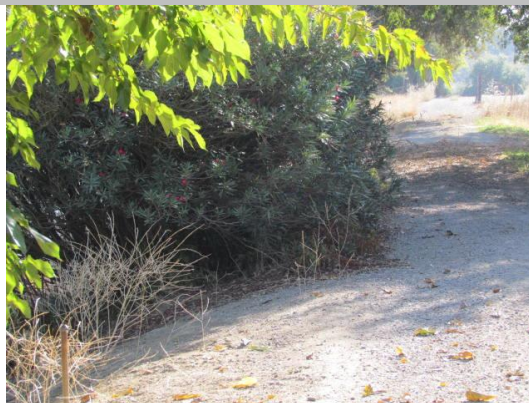
Photo 1 of 1 : SP_2018_RD0544_108_10_20180323_00017.jpg

LM Start	0.70	Rating **	U	Issue No.	10
LM End	0.70	Issue Type +	En	Location *	WS
Category	Earthen Levee			GPS Latitude/Longitude	
				Start	End
Item	Vegetation			37.863575 °	37.863575 °
				-121.322367 °	-121.322367 °
DWR ID	DWR_RD0544_01_s_2012_10				
Comment Code					
V6 : Landscaping					
Inspector Comment					
Oleander on waterside slope.

Looking south at dense oleanders on waterward slope fall 2015.

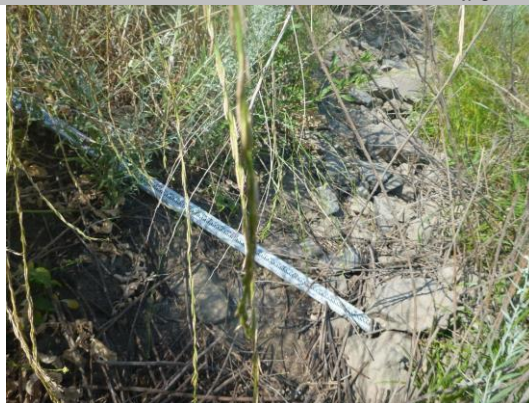
Photo 1 of 3 : LEVAL_SP_2018_570_4597.jpg

LM Start	0.99	Rating **	A/W	Issue No.	77
LM End	1.02	Issue Type +	Ma	Location *	
Category	Supplemental			GPS Latitude/Longitude	
				Start	End
Item	2017 Storm Damage			37.860400 °	37.860200 °
				-121.320300 °	-121.319700 °
DWR ID	DWR_RD0544_01_f _ 2017_77				
Comment Code					
Inspector Comment					
Levee Evaluation Comments					
Description:Slope protection repairs are needed along the waterside slope due to erosion and riprap displacement from high water. Based upon levee inspections, it was determined the waterside levee slope is eroding, deteriorating, and degrading. The eroded levee sections need to be restored back to design standards to prevent further deterioration and damage.					
Site ID No:570					
Site Designation:LMA-476					
Repair Type: Erosion					
Rating:Area of Concern					
Field Date:8/10/2017					
Notes:

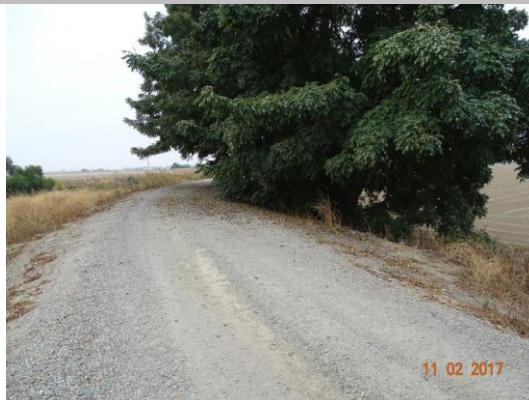
Photo 1 of 2 : SP_2018_RD0544_108_39_20180323_00033.jpg

LM Start	1.12	Rating **	A/W	Issue No.	39
LM End	1.12	Issue Type +	Ma	Location *	LS
Category	Earthen Levee			GPS Latitude/Longitude	
				Start	End
Item	Trim / Thin Trees			37.859423 °	37.859423 °
				-121.318328 °	-121.318328 °
DWR ID	DWR_RD0544_01_s_2012_39				
Comment Code					
T1 : Trim trees to at least five feet above ground level.					
Inspector Comment					
Untrimmed trees on landside slope.

Looking southwest at landside slope.

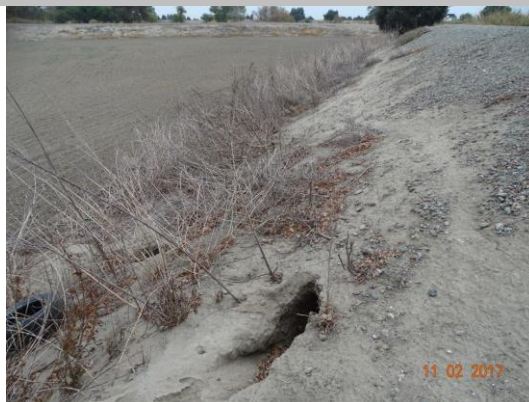
Photo 1 of 1 : SP_2018_RD0544_108_146_20180323_00136.jpg

LM Start	1.63	Rating **	U	Issue No.	146
LM End	1.63	Issue Type +	Ma	Location *	LS
Category	Earthen Levee			GPS Latitude/Longitude	
				Start	End
Item	Animal Control			37.854643 °	37.854643 °
				-121.322429 °	-121.322429 °
DWR ID	DWR_RD0544_01_f_2017_146				
Comment Code					
A3 : No rodents visible, but rodent burrows visible; need to backfill and compact or grout burrows.					
Inspector Comment					
Large rodent hole on landside slope.

Looking east at the landside slope.

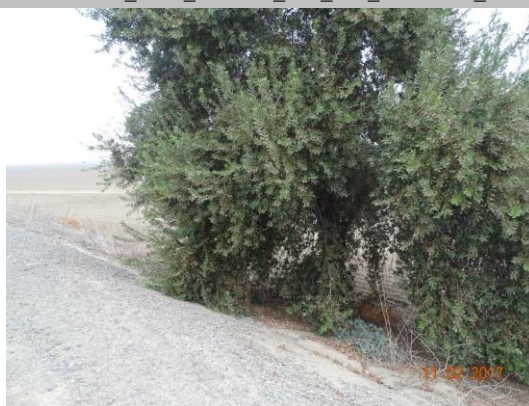
Photo 1 of 1 : SP_2018_RD0544_108_145_20180323_00135.jpg

LM Start	1.64	Rating **	A/W	Issue No.	145
LM End	1.64	Issue Type +	Ma	Location *	LS
Category	Earthen Levee			GPS Latitude/Longitude	
				Start	End
Item	Trim / Thin Trees			37.854673 °	37.854673 °
				-121.322492 °	-121.322492 °
DWR ID	DWR_RD0544_01_f_2017_145				
Comment Code					
T1 : Trim trees to at least five feet above ground level.					
Inspector Comment

Looking northwest at the landside slope.

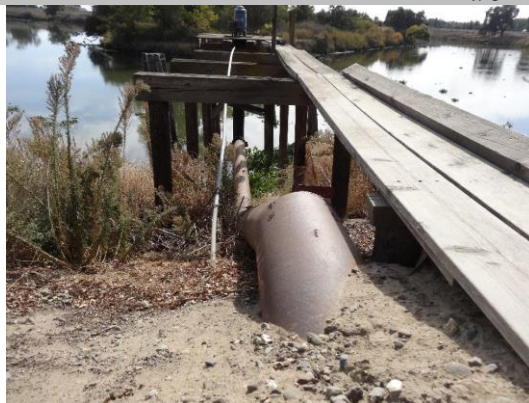
Photo 1 of 3 : UCIP_SP_2018_51351_41786.jpg

FS_ID:51351
DS_ID:22648
EP_NO: 4114
Repair Type: Non-Urgent
Crossing Status: Found
UCIP Comments: 12/22/2016: No signs of erosion or depressions found on either levee slope. Slope may have been backfilled but cause of original depression (likely a pipe integrity problem) may not have been addressed. Walkway still in poor structural condition. Downgraded this crossing from Urgent to Non-Urgent. (K. Fazel - UCIP)10/29/2013:- levee depression on both sides of the levee.- 2-inch electric conduit on waterside and service pole on landside.Walkway in poor structural condition. (P. Amatya - DWR)
FIELD_STRUCT_DESC: 18-inch steel irrigation discharge pipe through the levee, 2 feet below the crown. Pump mounted on a pile structure pier in the river. Siphon breaker on the apex of the pipe on the landside (LS) slope. Concrete standpipe at the LS toe. 2-inch electrical conduit through the levee. Service pole at the LS toe. (Plans to install a pump, pump structure, and one 20-inch pipeline through the levee authorized under Permit No. 4114, 1962 - Katie M. Feck). [Additional Reference(s): DWR Levee Log, 2005, 14-inch pipe referenced, 4.2 feet below the crown. USACE San Joaquin O&M Manual 7, April 1964, (HLM 1.73), 20-inch pipe, 4.2 feet below the crown, referenced].

WS view: pipe, conduit, walkway, and pump on levee slope.

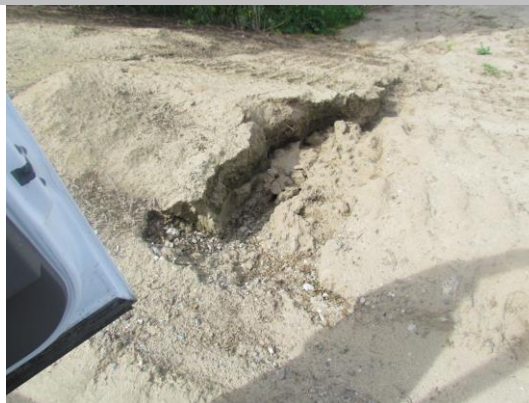
Photo 1 of 2 : SP_2018_RD0544_108_80_20180323_00058.jpg

LM Start	1.82	Rating **	U	Issue No.	80
LM End	1.82	Issue Type +	Ma	Location *	LS
Category	Earthen Levee			GPS Latitude/Longitude	
				Start	End
Item	Erosion / Bank Caving			37.853173 °	37.853173 °
				-121.324145 °	-121.324145 °
DWR ID	DWR_RD0544_01_s_2017_80				
Comment Code					
E2 : Schedule repair of erosion site prior to the next inspection.					
Inspector Comment					
Repair slope damage due to water runoff.

Looking west at slope damage due to rain runoff on waterward slope.

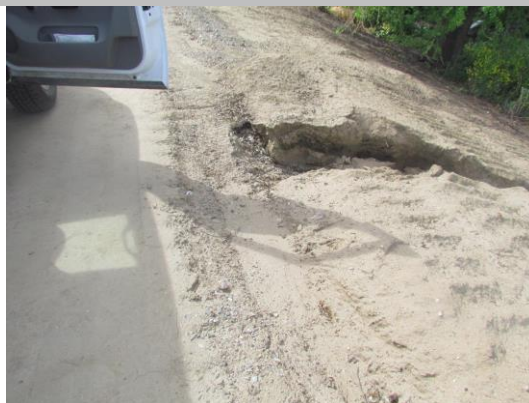
Photo 2 of 2 : SP_2018_RD0544_108_80_20180323_00059.jpg

Looking south at slope damage due to rain runoff on waterward slope.

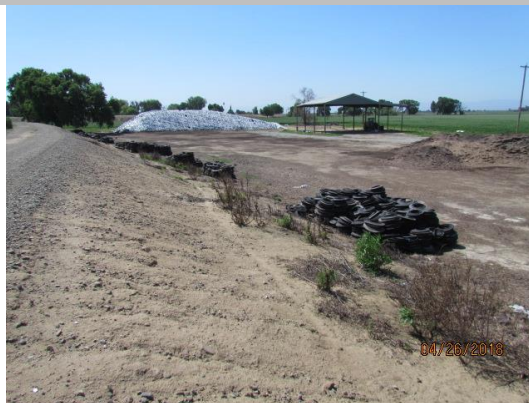
Photo 1 of 3 : SP_2018_RD0544_108_64_20180427_00183.jpg

LM Start	1.84	Rating **	U	Issue No.	64
LM End	1.93	Issue Type +	En	Location *	LS
Category	Earthen Levee			GPS Latitude/Longitude	
				Start	End
Item	Encroachments			37.852971 °	37.851746 °
				-121.324096 °	-121.323328 °
DWR ID	DWR_RD0544_01_f_2015_64				
Comment Code					
GA : Garbage					
Inspector Comment					
Plastic sheeting and rubber tires stored at landward toe.

Looking southwest at rubber tires stored along landward toe. (Spring 2018)

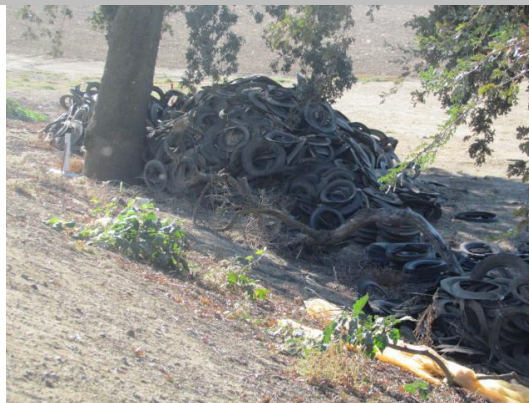
Photo 2 of 3 : SP_2018_RD0544_108_64_20180323_00047.jpg

Looking southwest at rubber tires stored at landward toe.

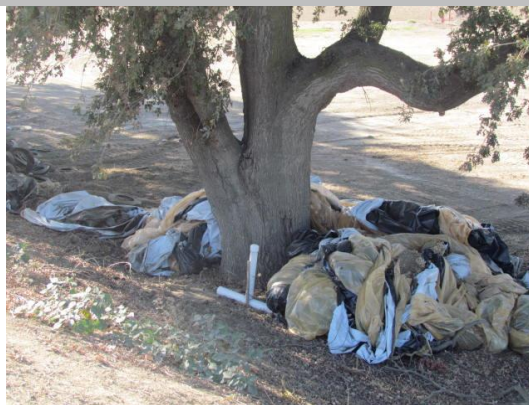
Photo 3 of 3 : SP_2018_RD0544_108_64_20180323_00046.jpg

Looking west at plastic sheeting stored at landward toe.

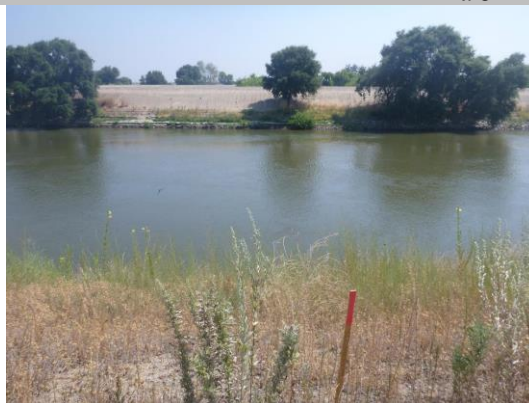
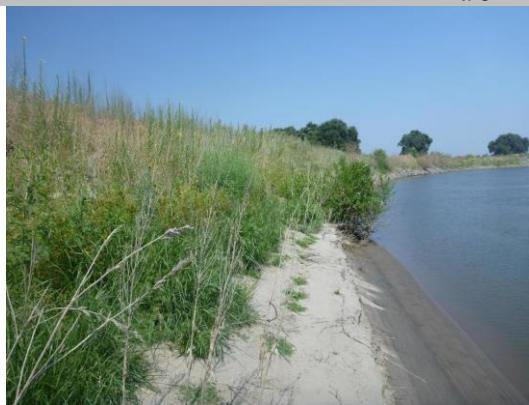
LM Start	1.89	Rating **	A/W	Issue No.	127
LM End	1.91	Issue Type +	Ma	Location *	
Category	Supplemental			GPS Latitude/Longitude	
				Start	End
Item	2017 Storm Damage			37.852300 °	37.852000 °
				-121.323700 °	-121.323600 °
DWR ID	DWR_RD0544_01_f_2017_127				
Comment Code					
Inspector Comment					
Levee Evaluation Comments					
Description:Slope protection repairs are needed along the waterside slope due to erosion and riprap displacement from high water. Based upon levee inspections, it was determined the waterside levee slope is eroding, deteriorating, and degrading. The eroded levee sections need to be restored back to design standards to prevent further deterioration and damage.					
Site ID No:569					
Site Designation:LMA-475					
Repair Type: Erosion					
Rating:Area of Concern					
Field Date:8/10/2017					
Notes:

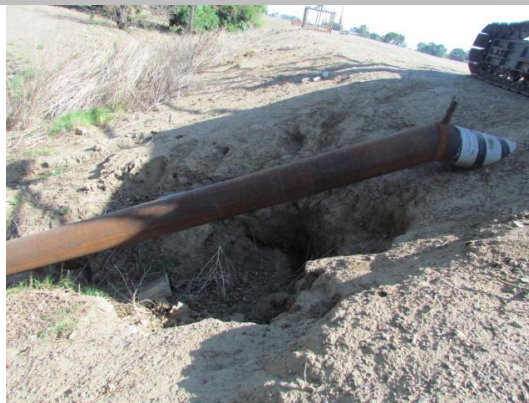
Photo 2 of 3 : SP_2018_RD0544_108_23_20180323_00025.jpg

LM Start	2.26	Rating **	U	Issue No.	23
LM End	2.26	Issue Type +	Ma	Location *	LS
Category	Earthen Levee			GPS Latitude/Longitude	
				Start	End
Item	Erosion / Bank Caving			37.848155 °	37.848155 °
				-121.324897 °	-121.324897 °
DWR ID	DWR_RD0544_01_s_2012_23				
Comment Code					
E2 : Schedule repair of erosion site prior to the next inspection.					
Inspector Comment					
Caving/erosion around irrigation pipe on landside slope.

Looking north at erosion under irrigation pipe on landside slope.

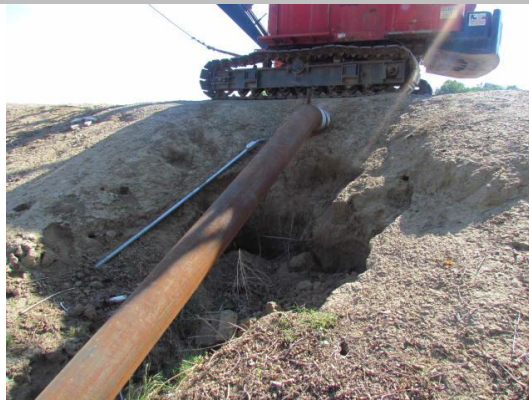
Photo 3 of 3 : SP_2018_RD0544_108_23_20180323_00026.jpg

Looking east at erosion under irrigation pipe on landside slope.

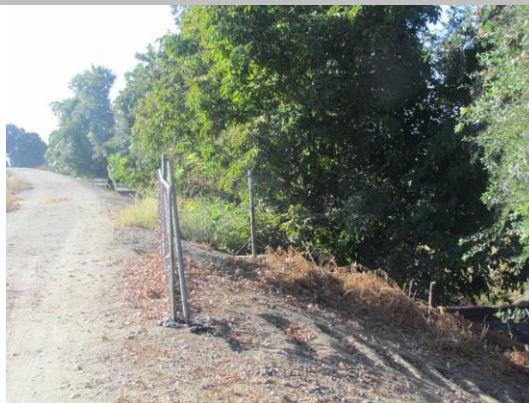
Photo 1 of 1 : SP_2018_RD0544_108_98_20180323_00073.jpg

LM Start	2.26	Rating **	A/W	Issue No.	98
LM End	2.31	Issue Type +	Ma	Location *	LS
Category	Earthen Levee			GPS Latitude/Longitude	
				Start	End
Item	Trim / Thin Trees			37.848021 °	37.847343 °
				-121.324839 °	-121.324672 °
DWR ID	DWR_RD0544_01_f_2014_98				
Comment Code					
T2 : Thin trees to allow visibility of the ground and room to flood fight.					
Inspector Comment					
Untrimmed trees on landside slope.

Looking south at untrimmed trees on landward slope.

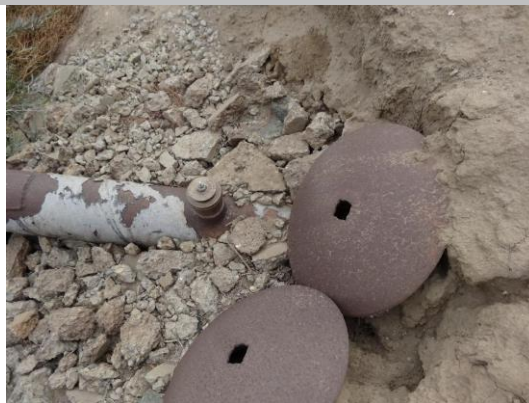
Photo 2 of 3 : UCIP_SP_2018_46671_44835.jpg

WS view: exposed steel pipe and soil erosion around siphon breaker on levee slope.

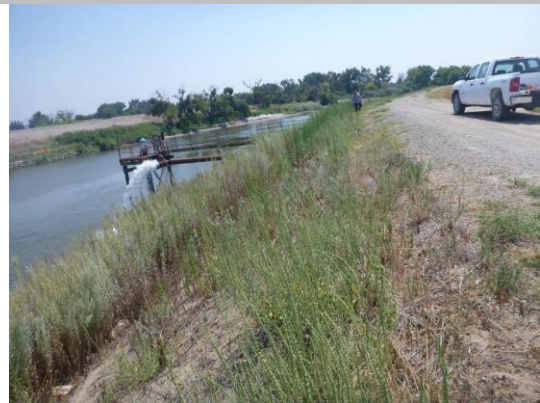
Photo 1 of 3 : LEVAL_SP_2018_567_4552.jpg

LM Start	2.53	Rating **	A/W	Issue No.	129
LM End	2.56	Issue Type +	Ma	Location *	
Category	Supplemental			GPS Latitude/Longitude	
				Start	End
Item	2017 Storm Damage			37.844900 °	37.844500 °
				-121.322300 °	-121.321900 °
DWR ID	DWR_RD0544_01_f _ 2017_129				
Comment Code					
Inspector Comment					
Levee Evaluation Comments					
Description:Slope protection repairs are needed along the waterside slope due to erosion and riprap displacement from high water. Based upon levee inspections, it was determined the waterside levee slope is eroding, deteriorating, and degrading. The eroded levee sections need to be restored back to design standards to prevent further deterioration and damage.					
Site ID No:567					
Site Designation:LMA-473					
Repair Type: Erosion					
Rating:Area of Concern					
Field Date:8/10/2017					
Notes: large rodent holes observed on landside slope.

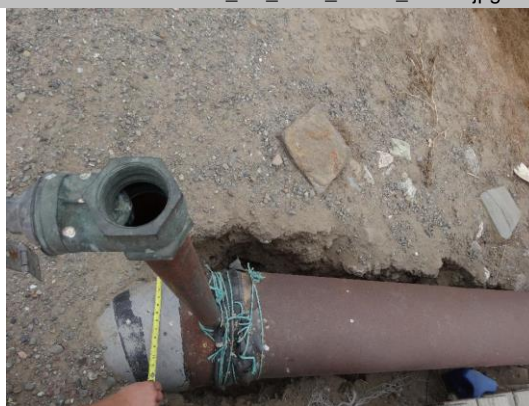
Photo 2 of 3 : UCIP_SP_2018_51361_44838.jpg

Comment Code						
Inspector Comment						
FS_ID:51361 DS_ID:22655 EP_NO: N/A Repair Type: Non-Urgent Crossing Status: Found UCIP Comments: 12/22/2016: Erosion has been backfilled. Slope has been repaired but unclear if the source of the erosion (a possible leak in pipe) was addressed. Crossing has been downgraded from Urgent to Non-Urgent. (K. Fazel - UCIP)10/29/2013:Siphon breaker on the landward shoulder not found.Service pole on landside.Huge erosion on landside and waterside of the levee due to the pipe leakage. (P. Amatya - DWR) FIELD_STRUCT_DESC: 12-inch steel irrigation discharge pipe through the levee, 2 feet below the crown. Pump mounted on a pile structure in the river. Steel walkway to the pump. Air relief valve on the waterside (WS) shoulder. Concrete distribution box at the landside (LS) toe. [Additional Reference(s): DWR Levee Log, 2005. USACE San Joaquin O&M Manual 7, April 1964, (HLM 2.58), 16-inch pipe, 12 feet below the crown, referenced]. FS Date: 12/22/2016

WS view: exposed pipe, air relief valve, and huge erosion on levee slope.

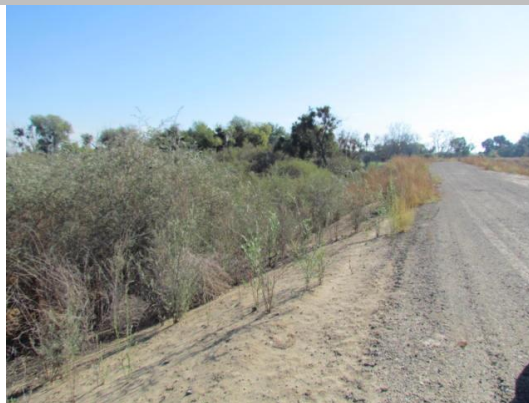
Photo 1 of 1 : SP_2018_RD0544_108_106_20180323_00077.jpg

LM Start	2.89	Rating **	U	Issue No.	106
LM End	3.16	Issue Type +	Ma	Location *	WS
Category	Earthen Levee			GPS Latitude/Longitude	
				Start	End
Item	Vegetation			37.840952 °	37.837588 °
				-121.319327 °	-121.317540 °
DWR ID	DWR_RD0544_01_s_2015_106				
Comment Code					
V2 : Remove the wild growth other than native grasses from the levee slopes.					
Inspector Comment					
Dense willows and vegetation on waterside slope.

Looking southeast at dense willows (veg) on waterward slope and toe fall 2015.

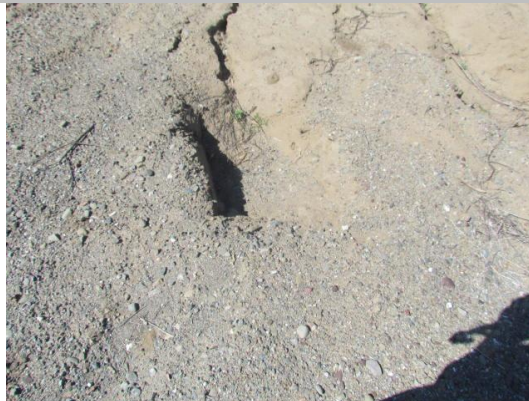
Photo 1 of 2 : SP_2018_RD0544_108_107_20180323_00078.jpg

LM Start	2.95	Rating **	M	Issue No.	107
LM End	2.96	Issue Type +	Ma	Location *	LS
Category	Earthen Levee			GPS Latitude/Longitude	
				Start	End
Item	Erosion / Bank Caving			37.840560 °	37.840467 °
				-121.318463 °	-121.318367 °
DWR ID	DWR_RD0544_01_s_2015_107				
Comment Code					
E1 : Note and monitor erosion site.					
Inspector Comment					
Several depressions on landside slope within this reach.

Looking south at depression on landward slope.

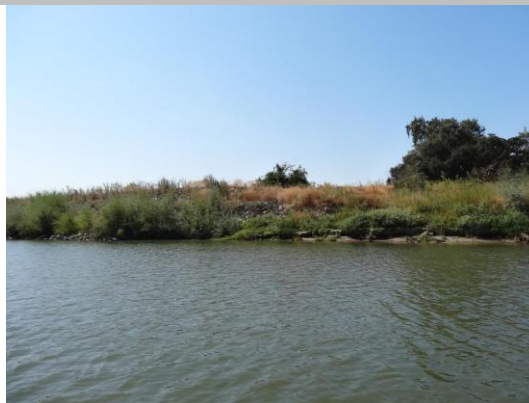
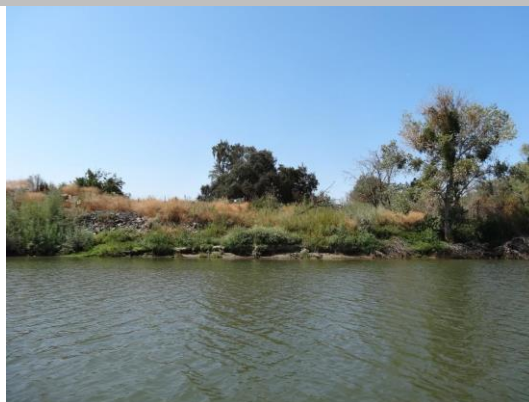
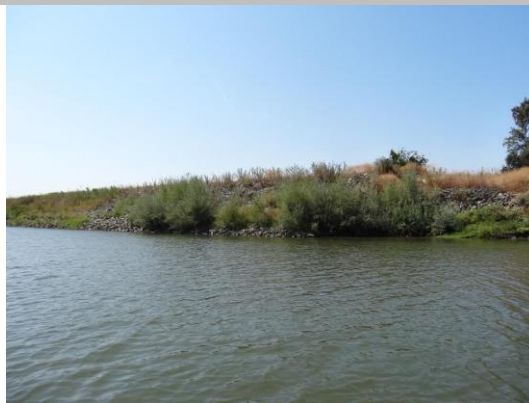
Front view of the erosion.

LM Start	2.95	Rating **	M	Issue No.	5 (cont)	
LM End	2.95	Issue Type +	Ma	Location *	WS	
Category	Supplemental			GPS Latitude/Longitude		
				Start		End
Item	DWR Erosion Survey			37.840697 °		37.840697 °
				-121.318252 °		-121.318252 °
DWR ID	RD0544U01RM49.67					
Comment Code						
Inspector Comment						
09/13/2017: No significant change observed.						
07/25/2016: No significant change observed.						
06/24/2015: No significant change observed.						
06/19/2014: No significant change observed.						
08/13/2013: Pump has been removed. A larger pocket erosion has been found at the erosion site.						
08/07/2012: The erosion is immediately upstream of a river bend.						
Dense vegetation is visible at the erosion site. [2017 Site ID:RD0544U01RM49.67]

Downstream view of the site.

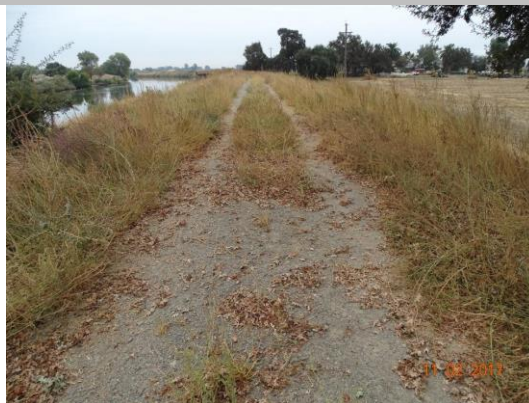
Photo 1 of 1 : SP_2018_RD0544_108_151_20180323_00137.jpg

LM Start	2.98	Rating **	A/W	Issue No.	151
LM End	3.18	Issue Type +	Ma	Location *	CR
Category	Earthen Levee			GPS Latitude/Longitude	
				Start	End
Item	Vegetation			37.840184 °	37.837294 °
				-121.318192 °	-121.317420 °
DWR ID	DWR_RD0544_01_f_2017_151				
Comment Code					
V2 : Remove the wild growth other than native grasses from the levee slopes.					
Inspector Comment

Looking south at the levee crown.

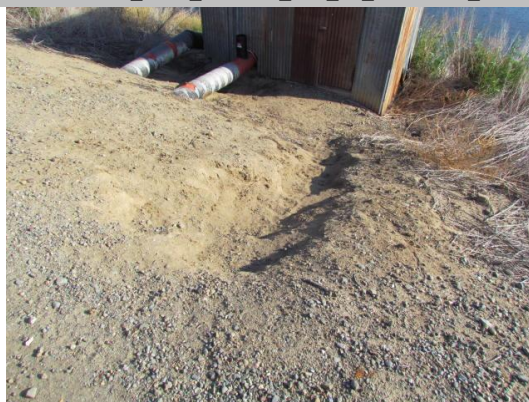
Photo 1 of 1 : SP_2018_RD0544_108_62_20180323_00045.jpg

LM Start	3.17	Rating **	M	Issue No.	62
LM End	3.17	Issue Type +	Ma	Location *	WS
Category	Earthen Levee			GPS Latitude/Longitude	
				Start	End
Item	Slope Stability			37.837530 °	37.837530 °
				-121.317510 °	-121.317510 °
DWR ID	DWR_RD0544_01_s_2012_62				
Comment Code					
S2 : Repair the levee slope damaged by foot traffic and prevent access where possible.					
Inspector Comment					
Slope damage due to foot traffic.

Looking east at slope damaged by foot traffic near pump house on waterside of levee.

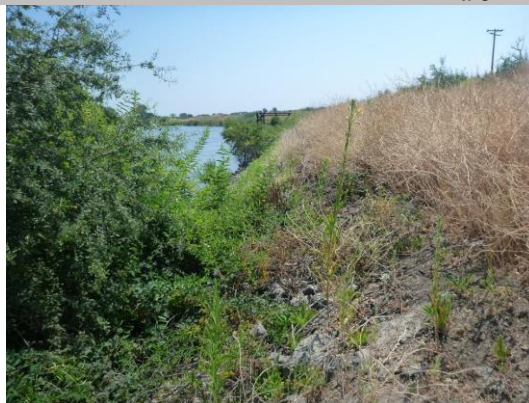
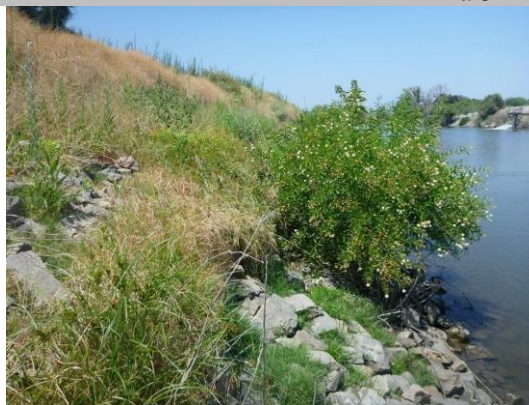
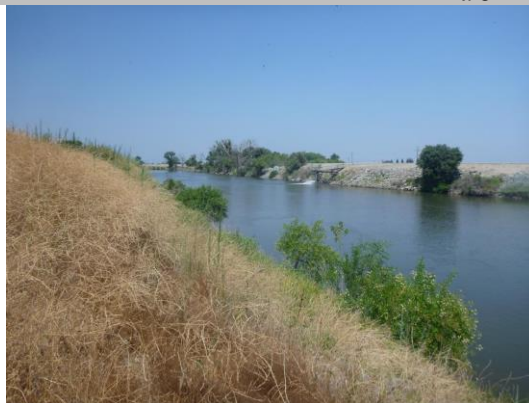
LM Start	3.21	Rating **	A/W	Issue No.	131
LM End	3.22	Issue Type +	Ma	Location *	
Category	Supplemental			GPS Latitude/Longitude	
				Start	End
Item	2017 Storm Damage			37.836900 °	37.836700 °
				-121.317300 °	-121.317300 °
DWR ID	DWR_RD0544_01_f_2017_131				
Comment Code					
Inspector Comment					
Levee Evaluation Comments					
Description:Slope protection repairs are needed along the waterside slope due to erosion and riprap displacement from high water. Based upon levee inspections, it was determined the waterside levee slope is eroding, deteriorating, and degrading. The eroded levee sections need to be restored back to design standards to prevent further deterioration and damage.					
Site ID No:566					
Site Designation:LMA-472					
Repair Type: Erosion					
Rating:Area of Concern					
Field Date:8/10/2017					
Notes:

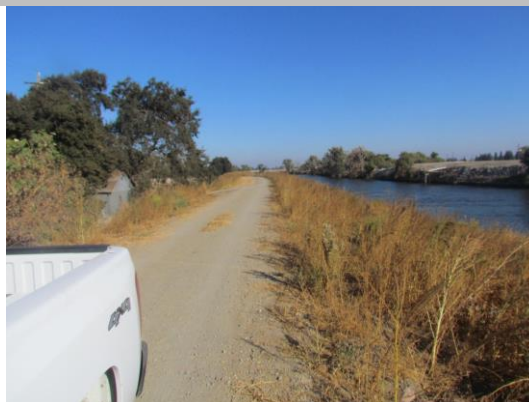
Photo 1 of 1 : SP_2018_RD0544_108_49_20180323_00040.jpg

LM Start	3.22	Rating **	U	Issue No.	49
LM End	3.84	Issue Type +	Ma	Location *	WS
Category	Earthen Levee			GPS Latitude/Longitude	
				Start	End
Item	Vegetation			37.836763 °	37.829195 °
				-121.317307 °	-121.311918 °
DWR ID	DWR_RD0544_01_s_2012_49				
Comment Code					
V2 : Remove the wild growth other than native grasses from the levee slopes.					
Inspector Comment					
Dense vegetation on waterside slope.

Looking northeast at dense veg on waterward slope.

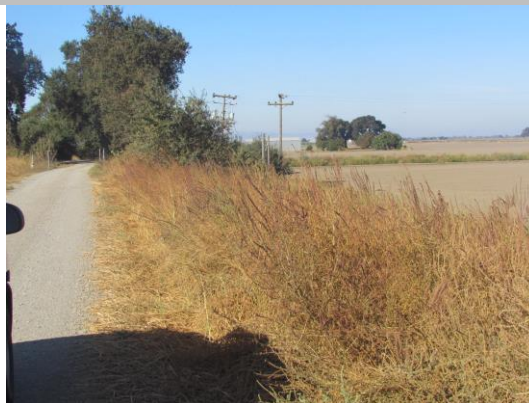
Photo 1 of 1 : SP_2018_RD0544_108_48_20180323_00039.jpg

LM Start	3.23	Rating **	U	Issue No.	48
LM End	3.26	Issue Type +	Ma	Location *	LS
Category	Earthen Levee			GPS Latitude/Longitude	
				Start	End
Item	Vegetation			37.836615 °	37.836133 °
				-121.317285 °	-121.317153 °
DWR ID	DWR_RD0544_01_s_2012_48				
Comment Code					
V2 : Remove the wild growth other than native grasses from the levee slopes.					
Inspector Comment

Looking south at typical view of dense veg on landward slope.

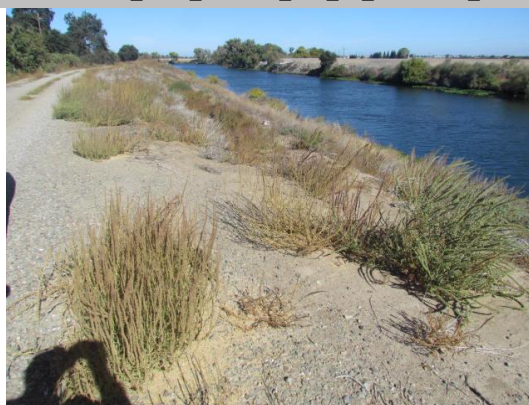
Photo 1 of 1 : SP_2018_RD0544_108_37_20180323_00032.jpg

LM Start	3.28	Rating **	M	Issue No.	37
LM End	3.28	Issue Type +	En	Location *	WS
Category	Earthen Levee			GPS Latitude/Longitude	
				Start	End
Item	Encroachments			37.835951 °	37.835951 °
				-121.317062 °	-121.317062 °
DWR ID	DWR_RD0544_01_s_2012_37				
Comment Code					
RA : Ramp					
Inspector Comment					
Landowner has cut new ramp on waterside slope.

Looking north at ramp on waterward slope.

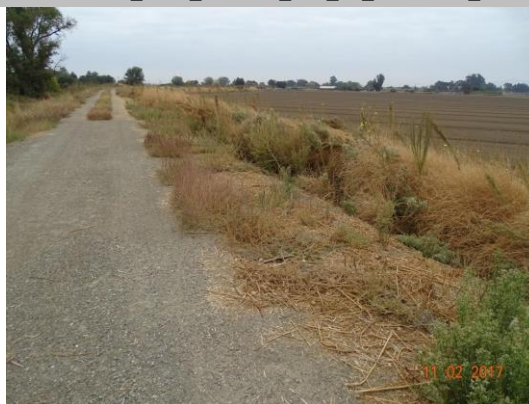
Photo 1 of 1 : SP_2018_RD0544_108_51_20180323_00041.jpg

LM Start	3.49	Rating **	U	Issue No.	51
LM End	4.67	Issue Type +	Ma	Location *	LS
Category	Earthen Levee			GPS Latitude/Longitude	
				Start	End
Item	Vegetation			37.833432 °	37.821853 °
				-121.314792 °	-121.319992 °
DWR ID	DWR_RD0544_01_s_2012_51				
Comment Code					
V2 : Remove the wild growth other than native grasses from the levee slopes.					
Inspector Comment

Looking southeast at the landside slope.

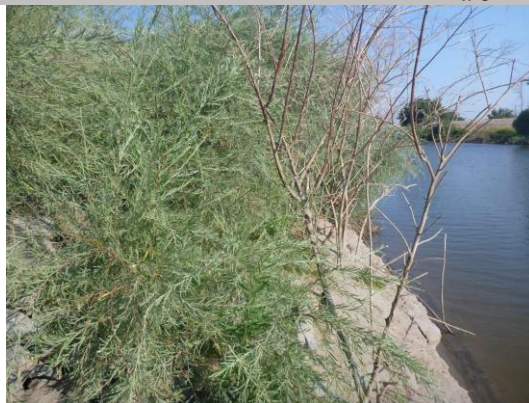
Photo 1 of 3 : LEVAL_SP_2018_565_4739.jpg

LM Start	3.65	Rating **	A/W	Issue No.	132
LM End	3.67	Issue Type +	Ma	Location *	
Category	Supplemental			GPS Latitude/Longitude	
				Start	End
Item	2017 Storm Damage			37.831800 °	37.831600 °
				-121.312700 °	-121.312600 °
DWR ID	DWR_RD0544_01_f_2017_132				
Comment Code					
Inspector Comment					
Levee Evaluation Comments					
Description:Slope protection repairs are needed along the waterside slope due to erosion and riprap displacement from high water. Based upon levee inspections, it was determined the waterside levee slope is eroding, deteriorating, and degrading. The eroded levee sections need to be restored back to design standards to prevent further deterioration and damage.					
Site ID No:565					
Site Designation:LMA-471					
Repair Type: Erosion					
Rating:Area of Concern					
Field Date:8/11/2017					
Notes: dense shrubs on levee slope

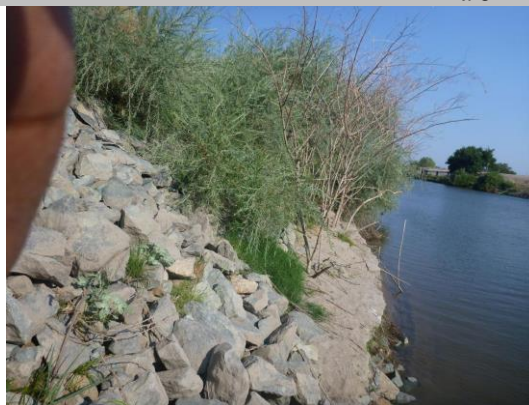
Photo 2 of 3 : LEVAL_SP_2018_565_4741.jpg

LM Start	3.65	Rating **	A/W	Issue No.	132 (cont)	
LM End	3.67	Issue Type +	Ma	Location *		
Category	Supplemental			GPS Latitude/Longitude		
				Start		End
Item	2017 Storm Damage			37.831800 °		37.831600 °
				-121.312700 °		-121.312600 °
DWR ID	DWR_RD0544_01_f_2017_132					
Comment Code						
Inspector Comment						
Levee Evaluation Comments						
Description:Slope protection repairs are needed along the waterside slope due to erosion and riprap displacement from high water. Based upon levee inspections, it was determined the waterside levee slope is eroding, deteriorating, and degrading. The eroded levee sections need to be restored back to design standards to prevent further deterioration and damage.						
Site ID No:565						
Site Designation:LMA-471						
Repair Type: Erosion						
Rating:Area of Concern						
Field Date:8/11/2017						
Notes: dense shrubs on levee slope

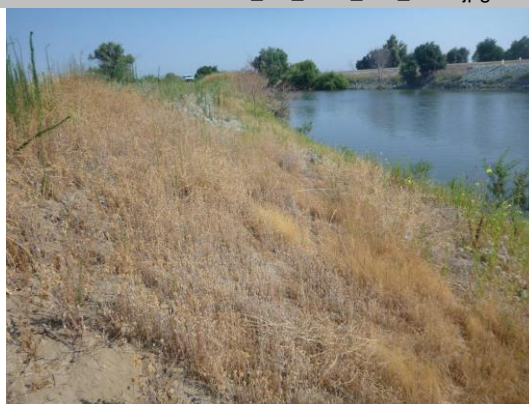
Photo 1 of 3 : LEVAL_SP_2018_564_4748.jpg

LM Start	3.69	Rating **	A/W	Issue No.	133
LM End	3.73	Issue Type +	Ma	Location *	
Category	Supplemental			GPS Latitude/Longitude	
				Start	End
Item	2017 Storm Damage			37.831300 °	37.830700 °
				-121.312600 °	-121.312300 °
DWR ID	DWR_RD0544_01_f_2017_133				
Comment Code					
Inspector Comment					
Levee Evaluation Comments					
Description:Slope protection repairs are needed along the waterside slope due to erosion and riprap displacement from high water. Based upon levee inspections, it was determined the waterside levee slope is eroding, deteriorating, and degrading. The eroded levee sections need to be restored back to design standards to prevent further deterioration and damage.					
Site ID No:564					
Site Designation:LMA-470					
Repair Type: Erosion					
Rating:Area of Concern					
Field Date:8/11/2017					
Notes: big rodent holes on levee slopes

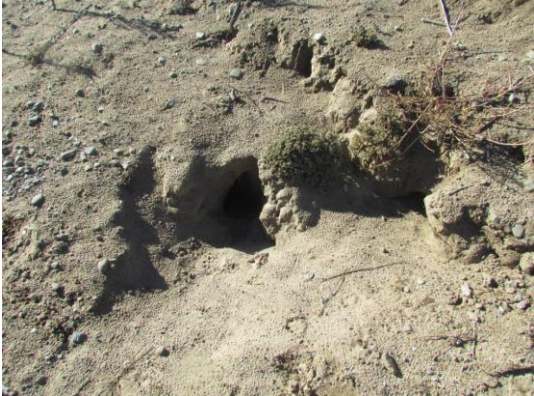
Photo 1 of 1 : SP_2018_RD0544_108_11_20180323_00018.jpg

Looking at large rodent holes on waterward slope.

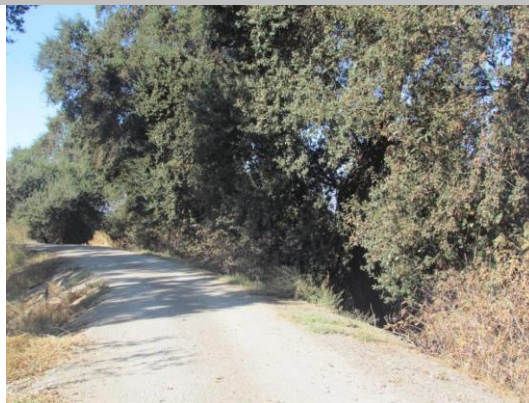
Photo 1 of 1 : SP_2018_RD0544_108_120_20180323_00092.jpg

LM Start	4.25	Rating **	U	Issue No.	120
LM End	4.28	Issue Type +	Ma	Location *	LS
Category	Earthen Levee			GPS Latitude/Longitude	
				Start	End
Item	Trim / Thin Trees			37.825482 °	37.825229 °
				-121.314298 °	-121.314771 °
DWR ID	DWR_RD0544_01_f_2015_120				
Comment Code					
T1 : Trim trees to at least five feet above ground level.					
Inspector Comment					
Several untrimmed trees on landside slope.

Looking southwest at untrimmed trees on landward slope.

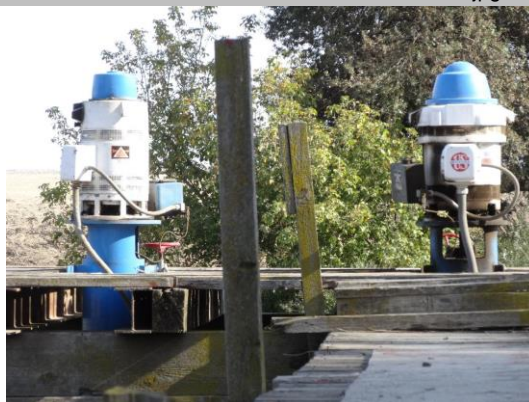
Photo 2 of 3 : UCIP_SP_2018_24893_44857.jpg

Comment Code					
Inspector Comment					
FS_ID:24893 DS_ID:22660 EP_NO: 11536 Repair Type: Non-Urgent Crossing Status: Found UCIP Comments: - siphon breaker was removed from CMP riser on landside shoulder. Needs replacement.- some details about existing pipes available in new Application no. 18903.- electric control box on landside and conduit on waterside. FIELD_STRUCT_DESC: 1 of 3: 12-inch coated steel irrigation discharge pipe through the levee, 3 feet below the crown. Pump on a pumping platform in the river with a walkway from the waterside (WS) slope. Siphon breaker in a corrugated metal pipe (CMP) riser and a concrete standpipe on the landside (LS). (Plans to install a platform and two irrigation pumps with two irrigation pipes and a drainage pipe through the levee, replacing an existing pump and irrigation pipe, authorized under Permit No. 11536, 1976 - Lloyd L. Phelps Sr). [Additional Reference(s): DWR Levee Log, 2005. USACE San Joaquin O&M Manual 7, April 1964, (HLM 4.33), pipe referenced as 8 feet below the crown]. FS Date: 10/29/2013

WS view: pumps, walkway to pump, and pile structure in the stream.

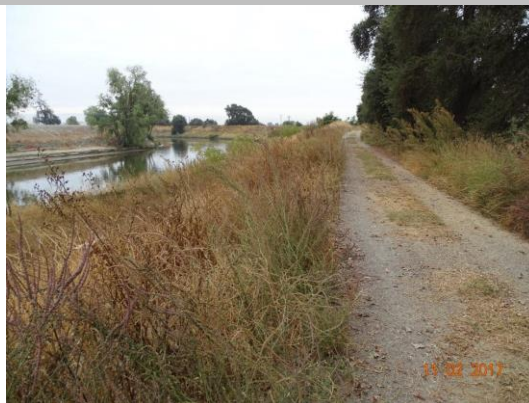
Photo 1 of 2 : SP_2018_RD0544_108_117_20180323_00086.jpg

LM Start	4.41	Rating **	U	Issue No.	117
LM End	4.79	Issue Type +	Ma	Location *	WS
Category	Earthen Levee			GPS Latitude/Longitude	
				Start	End
Item	Vegetation			37.823522 °	37.820557 °
				-121.315735 °	-121.321217 °
DWR ID	DWR_RD0544_01_s_2017_117				
Comment Code					
V2 : Remove the wild growth other than native grasses from the levee slopes.					
Inspector Comment

Looking southwest at the waterside slope.

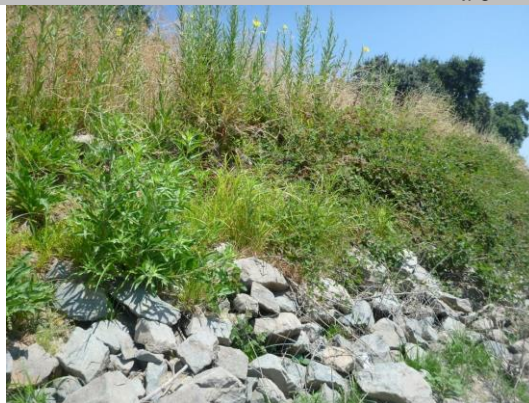
Photo 2 of 3 : LEVAL_SP_2018_561_4866.jpg

Item	2017 Storm Damage			37.823200 °		37.823000 °
				-121.316400 °		-121.316800 °
DWR ID	DWR_RD0544_01_f_2017_136					
Comment Code						
Inspector Comment						
Levee Evaluation Comments						
Description:Slope protection repairs are needed along the waterside slope due to erosion and riprap displacement from high water. Based upon levee inspections, it was determined the waterside levee slope is eroding, deteriorating, and degrading. The eroded levee sections need to be restored back to design standards to prevent further deterioration and damage.						
Site ID No:561						
Site Designation:LMA-467						
Repair Type: Erosion						
Rating:Area of Concern						
Field Date:8/11/2017						
Notes: site combined with LMA-466 in field; length and coordinates redefined in field.

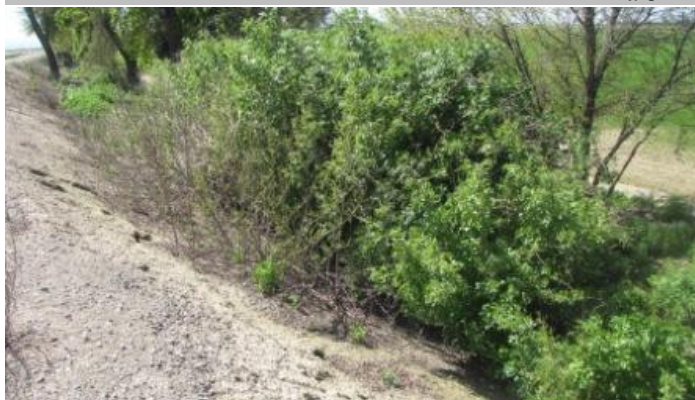
Photo 1 of 1 : SP_2018_RD0544_108_41_20180323_00035.jpg

LM Start	4.49	Rating **	U	Issue No.	41
LM End	4.49	Issue Type +	Ma	Location *	LS
Category	Earthen Levee			GPS Latitude/Longitude	
				Start	End
Item	Vegetation			37.822934 °	37.822934 °
				-121.316870 °	-121.316870 °
DWR ID	DWR_RD0544_01_s_2012_41				
Comment Code					
V4 : Elderberries are blocking visibility and flood fight capability.					
Inspector Comment

Looking south at elderberries on landside slope and toe.

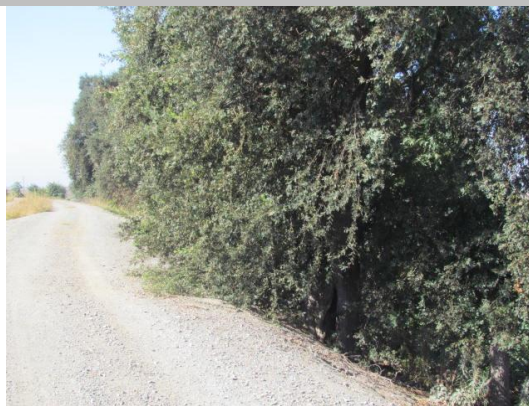
Photo 1 of 1 : SP_2018_RD0544_108_104_20180323_00075.jpg

LM Start	4.64	Rating **	U	Issue No.	104
LM End	4.68	Issue Type +	Ma	Location *	LS
Category	Earthen Levee			GPS Latitude/Longitude	
				Start	End
Item	Trim / Thin Trees			37.822033 °	37.821826 °
				-121.319432 °	-121.320071 °
DWR ID	DWR_RD0544_01_f_2014_104				
Comment Code					
T2 : Thin trees to allow visibility of the ground and room to flood fight.					
Inspector Comment					
Dense untrimmed trees on landside slope.

Looking southwest at dense untrimmed trees on landward slope fall 2015.

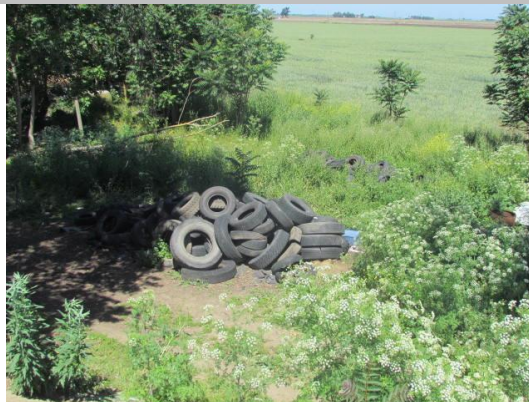
Photo 1 of 1 : SP_2018_RD0544_108_27_20180323_00027.jpg

LM Start	4.68	Rating **	U	Issue No.	27
LM End	4.69	Issue Type +	En	Location *	LS
Category	Earthen Levee			GPS Latitude/Longitude	
				Start	End
Item	Encroachments			37.821847 °	37.821793 °
				-121.320027 °	-121.320188 °
DWR ID	DWR_RD0544_01_s_2012_27				
Comment Code					
GA : Garbage					
Inspector Comment					
Tires stock pile on landside toe.

Looking west at tires stock pile on landward berm.

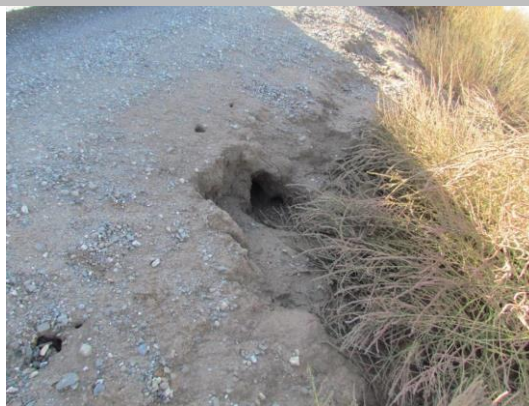
Photo 1 of 1 : SP_2018_RD0544_108_83_20180323_00061.jpg

LM Start	4.74	Rating **	U	Issue No.	83
LM End	4.74	Issue Type +	Ma	Location *	LS
Category	Earthen Levee			GPS Latitude/Longitude	
				Start	End
Item	Animal Control			37.821287 °	37.821287 °
				-121.320897 °	-121.320897 °
DWR ID	DWR_RD0544_01_f_2016_83				
Comment Code					
A3 : No rodents visible, but rodent burrows visible; need to backfill and compact or grout burrows.					
Inspector Comment					
Large rodent hole on waterside shoulder.

Looking at large rodent hole on landward slope.

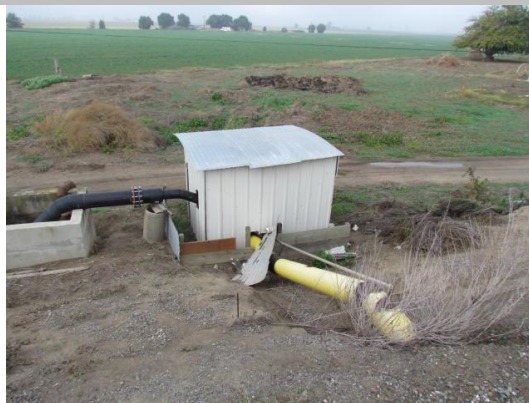
Photo 1 of 1 : SP_2018_RD0544_108_45_20180323_00037.jpg

LM Start	4.75	Rating **	M	Issue No.	45
LM End	4.75	Issue Type +	En	Location *	LS
Category	Earthen Levee			GPS Latitude/Longitude	
				Start	End
Item	Encroachments			37.821177 °	37.821177 °
				-121.321013 °	-121.321013 °
DWR ID	DWR_RD0544_01_s_2012_45				
Comment Code					
BU : Building					
Inspector Comment					
New unauthorized pump shed on landside toe.

Looking west at a unauthorized pump house on landside toe.

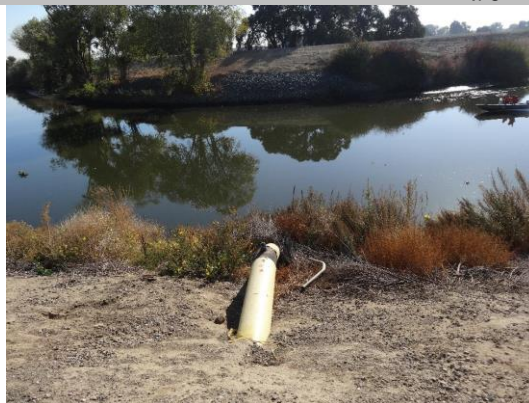
Photo 1 of 3 : UCIP_SP_2018_51379_44864.jpg

FS_ID:51379
 DS_ID:22661
 EP_NO: N/A
 Repair Type: Urgent
 Crossing Status: Found
 UCIP Comments: 12/22/2016: LS slope still eroded and in need of repair. WS slope shows no signs of problems. (K. Fazel - UCIP)10/31/2013:- huge erosion on landside slope due to leaky pipe.- small depression on waterside slope. (P. Amatya - DWR)
 FIELD_STRUCT_DESC: 12-inch steel irrigation discharge pipe through the levee, 4.4 feet below the crown. Pump house on the landside (LS) slope. Newly installed pump with a shutoff valve on the waterside (WS) slope. Pressure relief valve on the LS slope. Concrete distribution box with a shutoff valve on the pipe at the LS toe. [Additional Reference(s): DWR Levee Log, 2005. USACE San Joaquin O&M Manual 7, April 1964, (HLM 4.79), 14-inch pipe, 12 feet below the crown, referenced].
 FS Date: 12/22/2016

WS view: exposed steel pipe on levee slope.

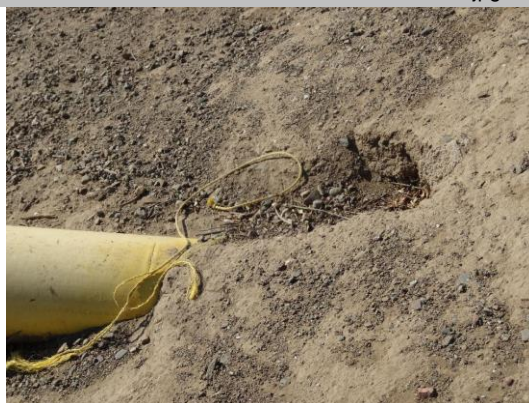
Photo 2 of 3 : UCIP_SP_2018_51379_44863.jpg

WS view: exposed steel pipe and a small depression on levee slope.
May be due to leaky pipe.

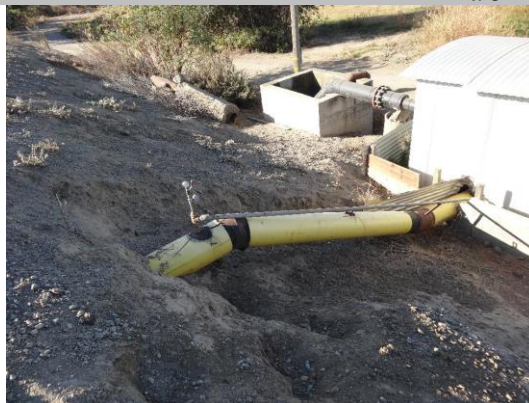
Photo 3 of 3 : UCIP_SP_2018_51379_44862.jpg

Comment Code						
Inspector Comment						
FS_ID:51379 DS_ID:22661 EP_NO: N/A Repair Type: Urgent Crossing Status: Found UCIP Comments: 12/22/2016: LS slope still eroded and in need of repair. WS slope shows no signs of problems. (K. Fazel - UCIP)10/31/2013:- huge erosion on landside slope due to leaky pipe.- small depression on waterside slope. (P. Amatya - DWR) FIELD_STRUCT_DESC: 12-inch steel irrigation discharge pipe through the levee, 4.4 feet below the crown. Pump house on the landside (LS) slope. Newly installed pump with a shutoff valve on the waterside (WS) slope. Pressure relief valve on the LS slope. Concrete distribution box with a shutoff valve on the pipe at the LS toe. [Additional Reference(s): DWR Levee Log, 2005. USACE San Joaquin O&M Manual 7, April 1964, (HLM 4.79), 14-inch pipe, 12 feet below the crown, referenced]. FS Date: 12/22/2016

LS view: distribution box (top-left), pumphouse (right) and exposed leaky pipe on eroded levee slope.

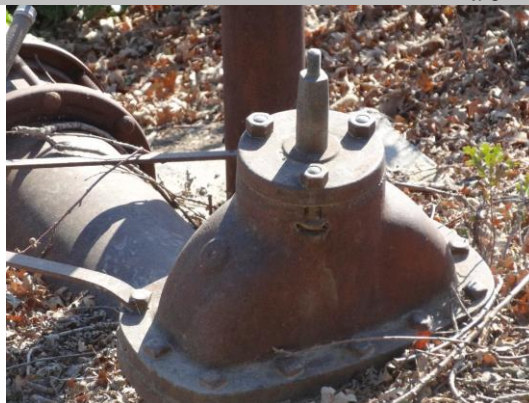
Photo 2 of 3 : UCIP_SP_2018_42962_42876.jpg

Comment Code						
Inspector Comment						
FS_ID:42962						
DS_ID:22662						
EP_NO: 1738						
Repair Type: Non-Urgent						
Crossing Status: Found						
UCIP Comments: Appears abandoned and if so should be done so properly. No handle on gatevalve on WS slope.						
FIELD_STRUCT_DESC: 12-inch steel irrigation discharge pipe through the levee, 6 feet below the crown. Slant pump and gate valve on the waterside (WS) slope. Electrical conduit through the levee and on the landside (LS). Service pole on the LS. Two concrete standpipes on the LS. (Plans for the construction of a pipeline through the levee authorized under Permit No. 1738, 1953 - Barker Corporation).						
[Additional Reference(s): DWR Levee Log, 2005. USACE San Joaquin O&M Manual 7, April 1964, (HLM 4.82)].						
FS Date: 10/31/2013

WS view: gate valve without handwheel on levee slope.

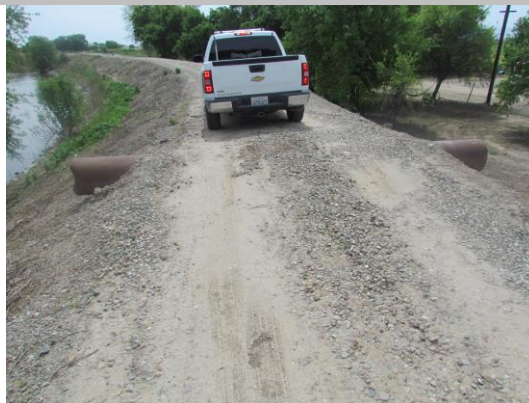
Photo 1 of 1 : SP_2018_RD0544_108_28_20180323_00028.jpg

LM Start	4.80	Rating **	M	Issue No.	28
LM End	4.80	Issue Type +	En	Location *	CR
Category	Earthen Levee			GPS Latitude/Longitude	
				Start	End
Item	Encroachments			37.820412 °	37.820412 °
				-121.321193 °	-121.321193 °
DWR ID	DWR_RD0544_01_s_2017_28				
Comment Code					
PI : Pipe					
Inspector Comment					
Pipe installed near surface of crown. Pipe is not connected on either side.

Looking south at pipe across levee crown.

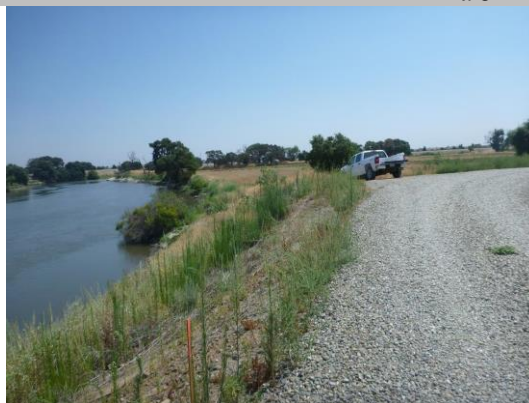
Photo 1 of 3 : LEVAL_SP_2018_559_4887.jpg

LM Start	4.97	Rating **	A/W	Issue No.	139
LM End	4.99	Issue Type +	Ma	Location *	
Category	Supplemental			GPS Latitude/Longitude	
				Start	End
Item	2017 Storm Damage			37.818600 °	37.818400 °
				-121.319200 °	-121.319000 °
DWR ID	DWR_RD0544_01_f_2017_139				
Comment Code					
Inspector Comment					
Levee Evaluation Comments					
Description:Slope protection repairs are needed along the waterside slope due to erosion and riprap displacement from high water. Based upon levee inspections, it was determined the waterside levee slope is eroding, deteriorating, and degrading. The eroded levee sections need to be restored back to design standards to prevent further deterioration and damage.					
Site ID No:559					
Site Designation:LMA-465					
Repair Type: Erosion					
Rating:Serious					
Field Date:8/11/2017					
Notes:

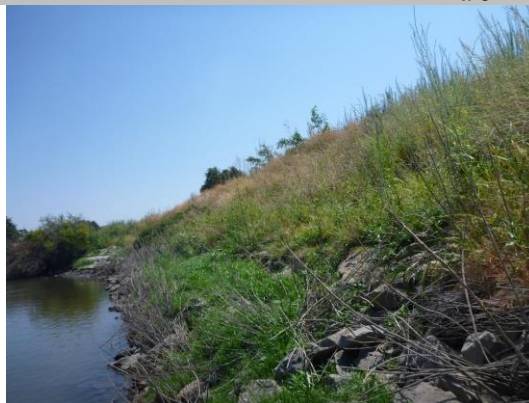
Photo 2 of 3 : LEVAL_SP_2018_559_4892.jpg

LM Start	4.97	Rating **	A/W	Issue No.	139 (cont)	
LM End	4.99	Issue Type +	Ma	Location *		
Category	Supplemental			GPS Latitude/Longitude		
				Start	End	
Item	2017 Storm Damage			37.818600 °	37.818400 °	
				-121.319200 °	-121.319000 °	
DWR ID	DWR_RD0544_01_f_2017_139					
Comment Code						
Inspector Comment						
Levee Evaluation Comments						
Description:Slope protection repairs are needed along the waterside slope due to erosion and riprap displacement from high water. Based upon levee inspections, it was determined the waterside levee slope is eroding, deteriorating, and degrading. The eroded levee sections need to be restored back to design standards to prevent further deterioration and damage.						
Site ID No:559						
Site Designation:LMA-465						
Repair Type: Erosion						
Rating:Serious						
Field Date:8/11/2017						
Notes:

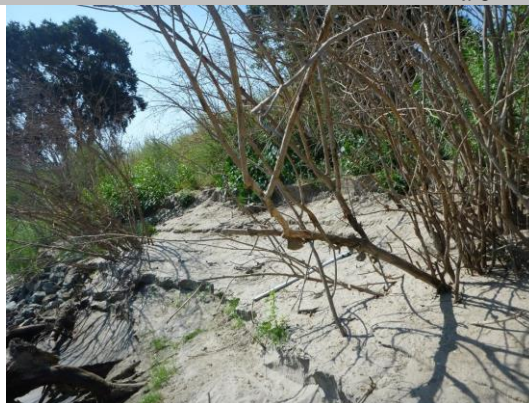
Photo 3 of 3 : LEVAL_SP_2018_558_4910.jpg

LM Start	5.32	Rating **	A/W	Issue No.	140 (cont)
LM End	5.36	Issue Type +	Ma	Location *	
Category	Supplemental		GPS Latitude/Longitude		
			Start	End	
Item	2017 Storm Damage		37.813900 °	37.813500 °	
			-121.319900 °	-121.319400 °	
DWR ID	DWR_RD0544_01_f_2017_140				
Comment Code					
Inspector Comment					
<p>Levee Evaluation Comments</p> <p>Description: Slope protection repairs are needed along the waterside slope due to erosion and riprap displacement from high water. Based upon levee inspections, it was determined the waterside levee slope is eroding, deteriorating, and degrading. The eroded levee sections need to be restored back to design standards to prevent further deterioration and damage.</p> <p>Site ID No: 558</p> <p>Site Designation: LMA-464</p> <p>Repair Type: Erosion</p> <p>Rating: Serious</p> <p>Field Date: 8/16/2017</p> <p>Notes:</p>

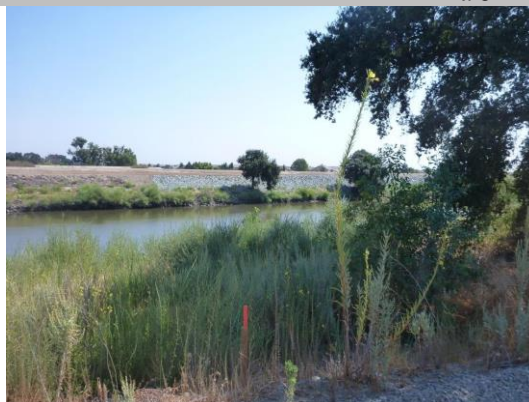
Photo 1 of 3 : LEVAL_SP_2018_557_4510.jpg

LM Start	5.36	Rating **	A/W	Issue No.	141
LM End	5.37	Issue Type +	Ma	Location *	
Category	Supplemental		GPS Latitude/Longitude		
			Start	End	
Item	2017 Storm Damage		37.813400 °	37.813300 °	
			-121.319300 °	-121.319200 °	
DWR ID	DWR_RD0544_01_f_2017_141				
Comment Code					
Inspector Comment					
<p>Levee Evaluation Comments</p> <p>Description: Slope protection repairs are needed along the waterside slope due to erosion and riprap displacement from high water. Based upon levee inspections, it was determined the waterside levee slope is eroding, deteriorating, and degrading. The eroded levee sections need to be restored back to design standards to prevent further deterioration and damage.</p> <p>Site ID No: 557</p> <p>Site Designation: LMA-463</p> <p>Repair Type: Erosion</p> <p>Rating: Area of Concern</p> <p>Field Date: 8/16/2017</p> <p>Notes:</p>

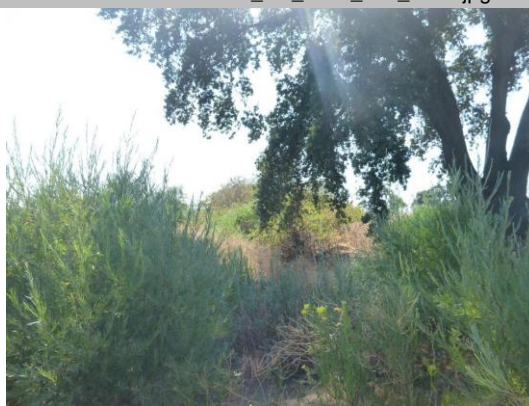
Photo 2 of 3 : LEVAL_SP_2018_557_4513.jpg

LM Start	5.36	Rating **	A/W	Issue No.	141 (cont)
LM End	5.37	Issue Type +	Ma	Location *	
Category	Supplemental			GPS Latitude/Longitude	
				Start	End
Item	2017 Storm Damage			37.813400 °	37.813300 °
				-121.319300 °	-121.319200 °
DWR ID	DWR_RD0544_01_f_2017_141				
Comment Code					
Inspector Comment					
Levee Evaluation Comments					
Description:Slope protection repairs are needed along the waterside slope due to erosion and riprap displacement from high water. Based upon levee inspections, it was determined the waterside levee slope is eroding, deteriorating, and degrading. The eroded levee sections need to be restored back to design standards to prevent further deterioration and damage.					
Site ID No:557					
Site Designation:LMA-463					
Repair Type: Erosion					
Rating:Area of Concern					
Field Date:8/16/2017					
Notes:
